# Michigan Non-NBI Culvert Structure Inspection Guide

Michigan  
Transportation Asset  
Management Council

September 2021

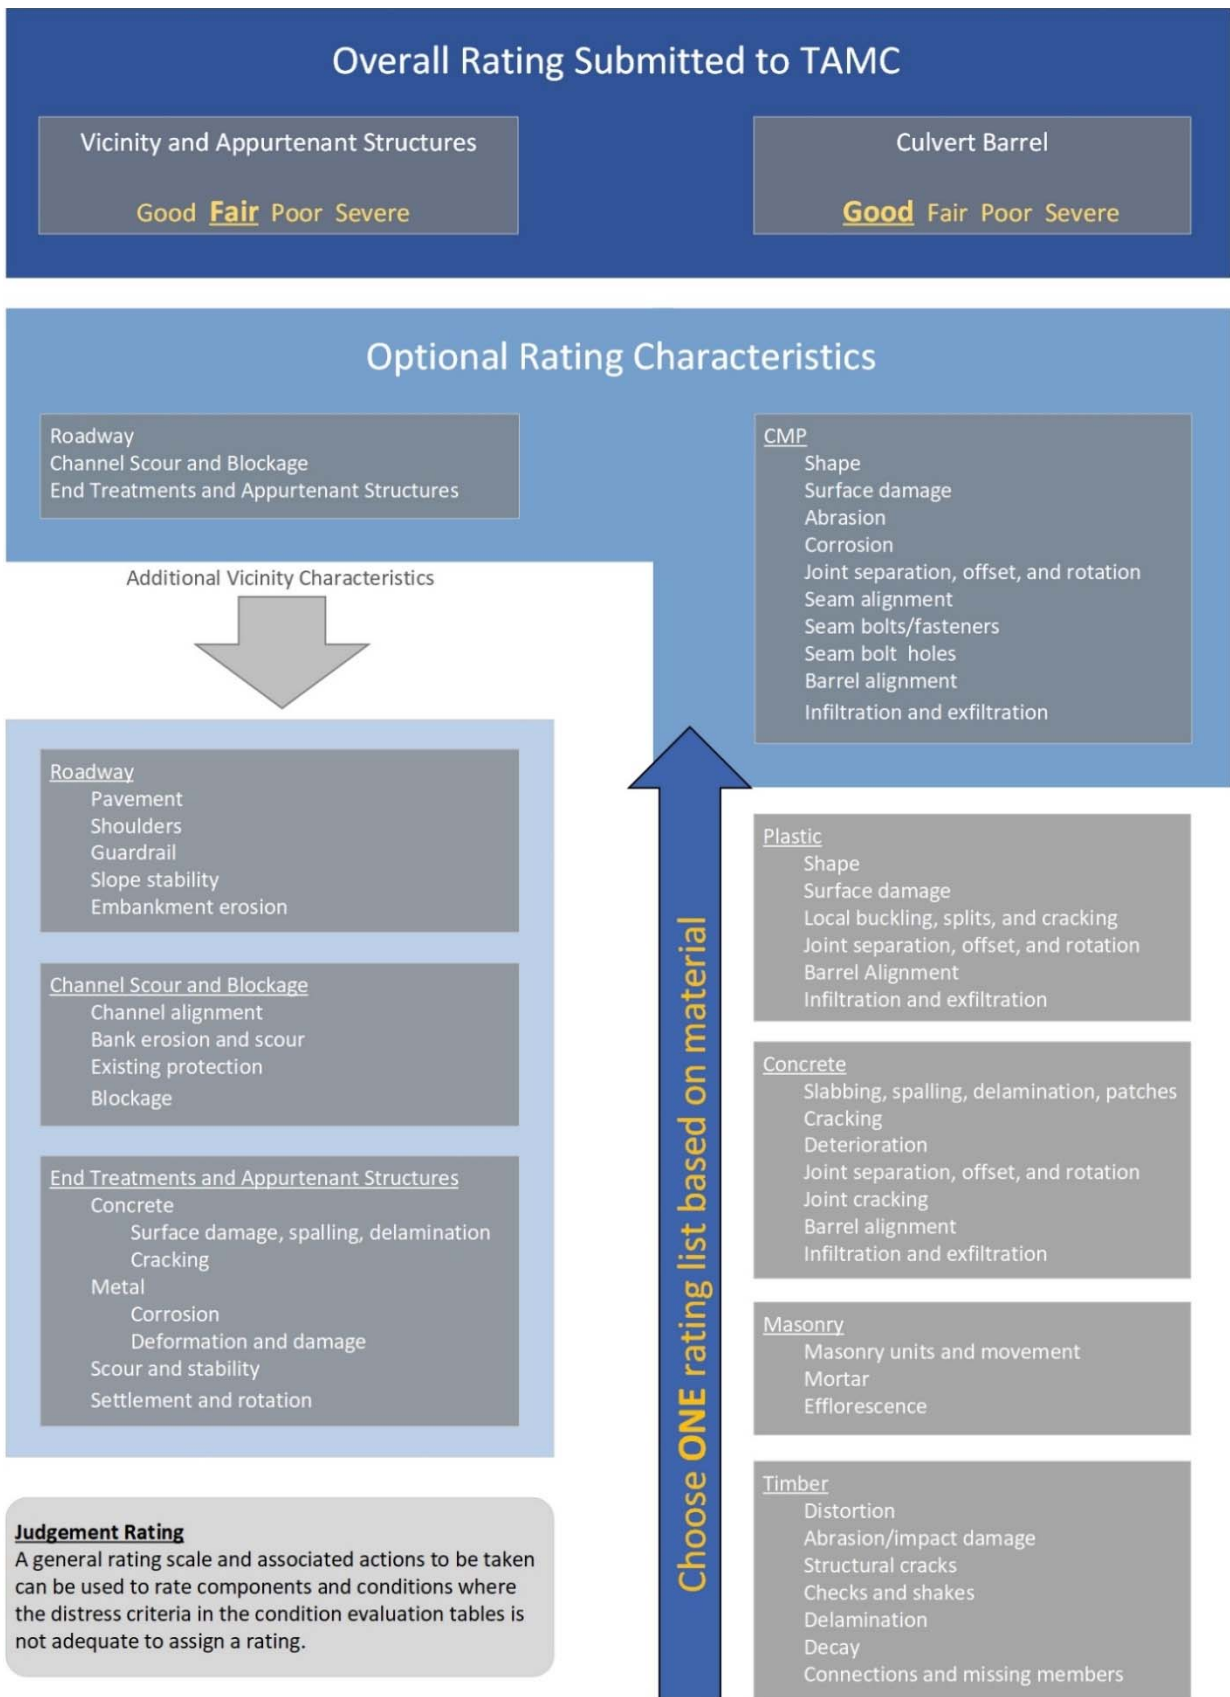
Figure 3 Culvert condition rating component flowchart

Components and characteristics that may be rated using this culvert condition rating system include the vicinity and appurtenant structures component category—roadway, channel scour and blockage, and end treatments and appurtenant structures—and culvert barrel component category—barrel condition, alignment, joints, and seams. Each component category’s rating—that is, the rating of the vicinity and appurtenant structures component category and the culvert barrel component category—is determined by rating the culvert’s components and characteristics and assigning an overall score (see Figure 3). A component-category-level assessment identifies distresses more effectively and provides a better understanding of the appropriate action to address those distresses.

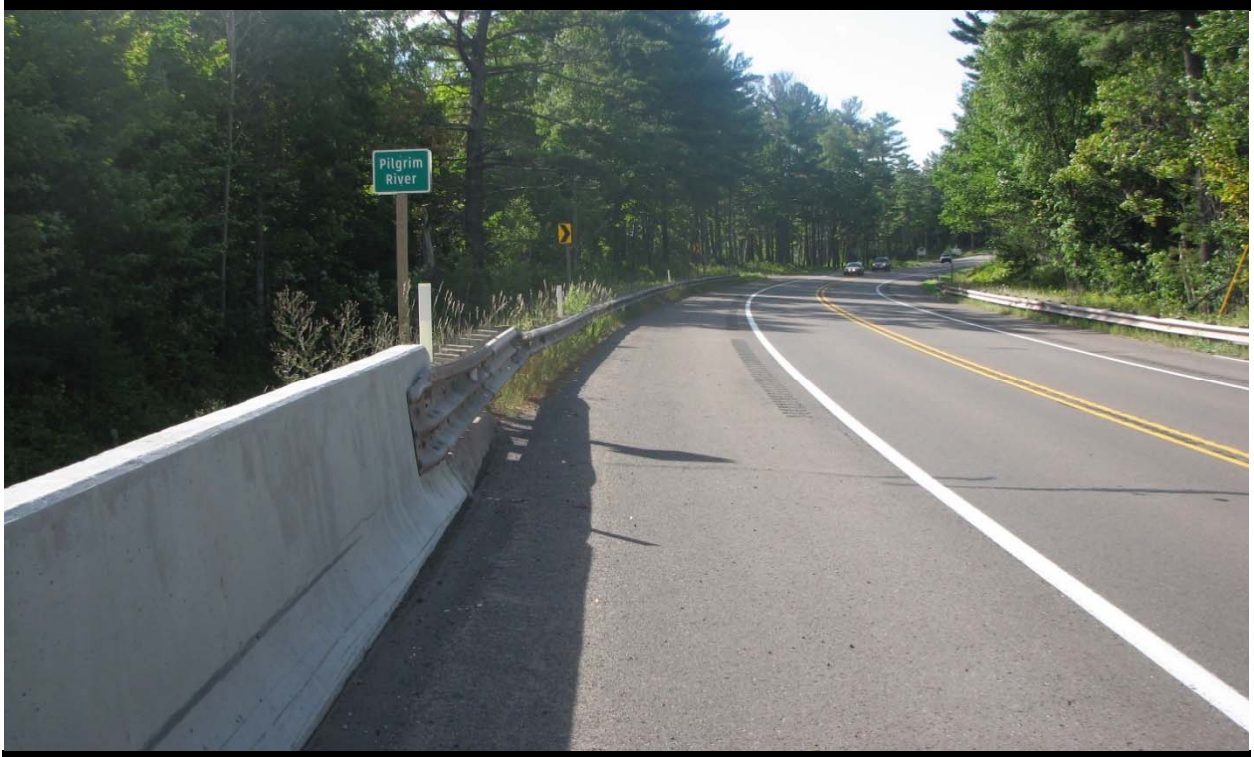
*Figure 4 The condition of the roadway and embankment can help identify distress within a culvert below. Characteristics to inspect include the pavement, guardrail, shoulders, slope stability, and embankment erosion.*

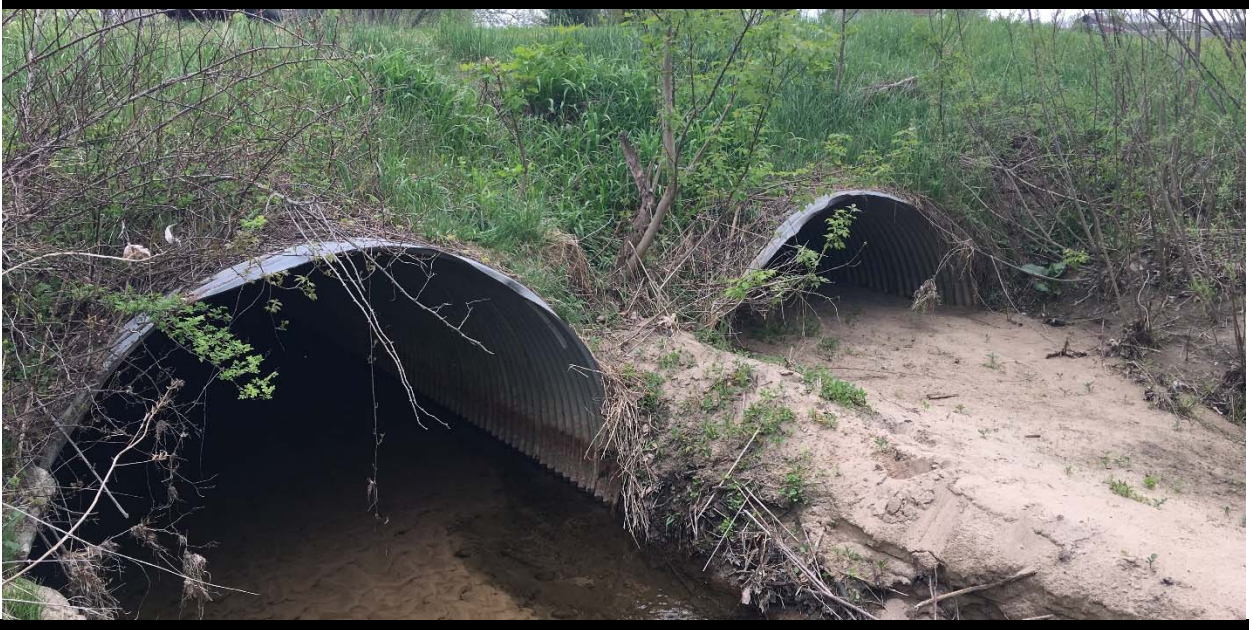
*Figure 5 Culvert placement can cause damage to the area around the culvert due to scour or ineffectiveness due to blockage. The characteristics to inspect include channel alignment, bank erosion & scour, existing scour protection, and blockage.*

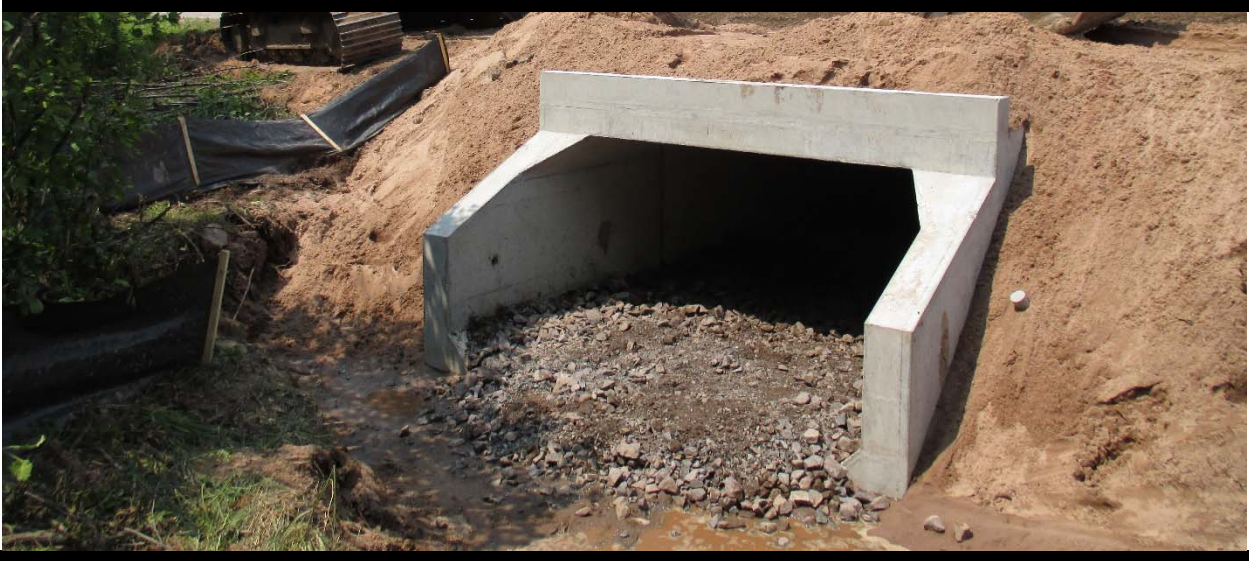
*Figure 6 End treatments are designed to protect the culvert barrel and surrounding area from erosion and seepage. Concrete end treatments are checked for cracking and surface damage. Metal treatments are inspected for deformation and corrosion. Additionally, end treatments should be evaluated for scour and stability and for settlement and rotation.*

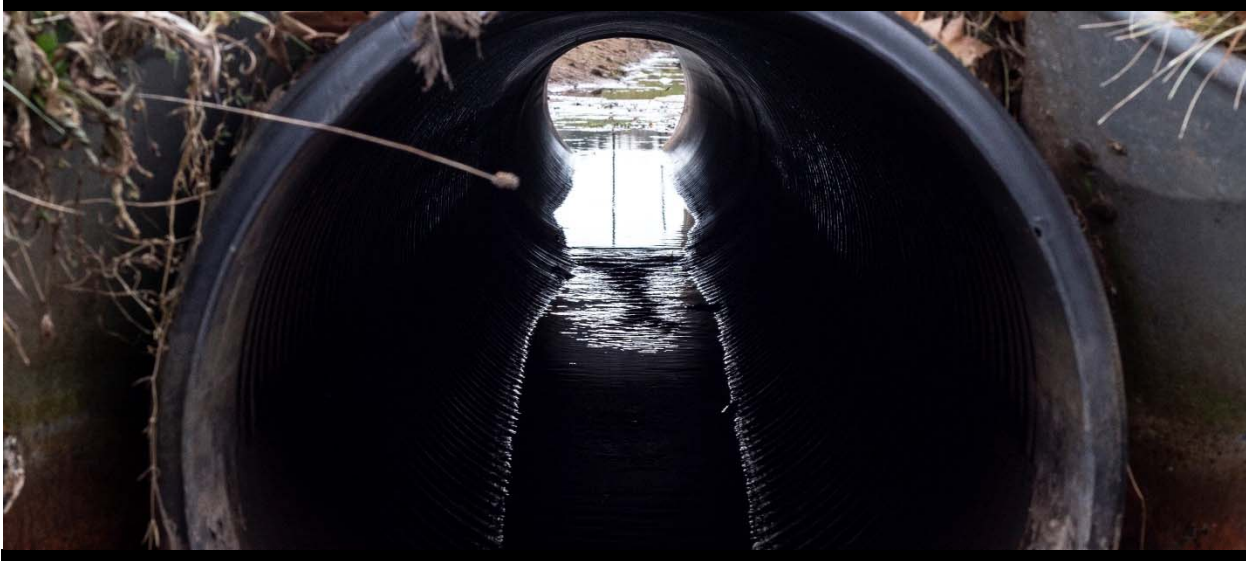
*Figure 7 Plastic barrels need to be checked for changes to their cross-sectional shape, surface damage, local buckling, joints, alignment, and infiltration and exfiltration.*

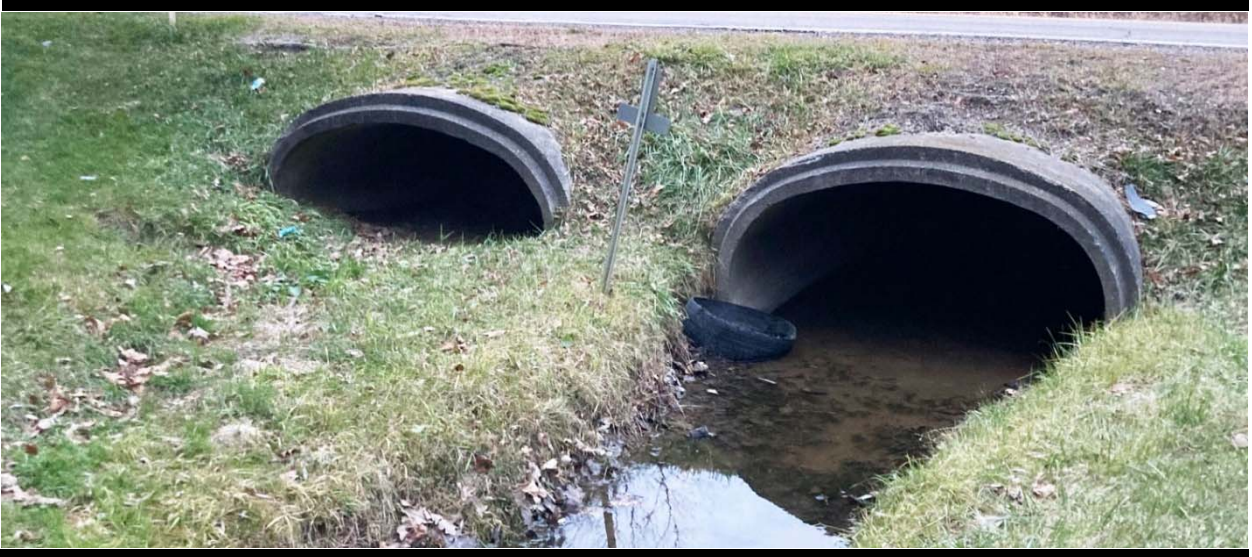
*Figure 8 Concrete barrels should be checked for cracking, spalling, deterioration, joints, alignment, and infiltration and exfiltration (photo: Kent County Road Commission)*

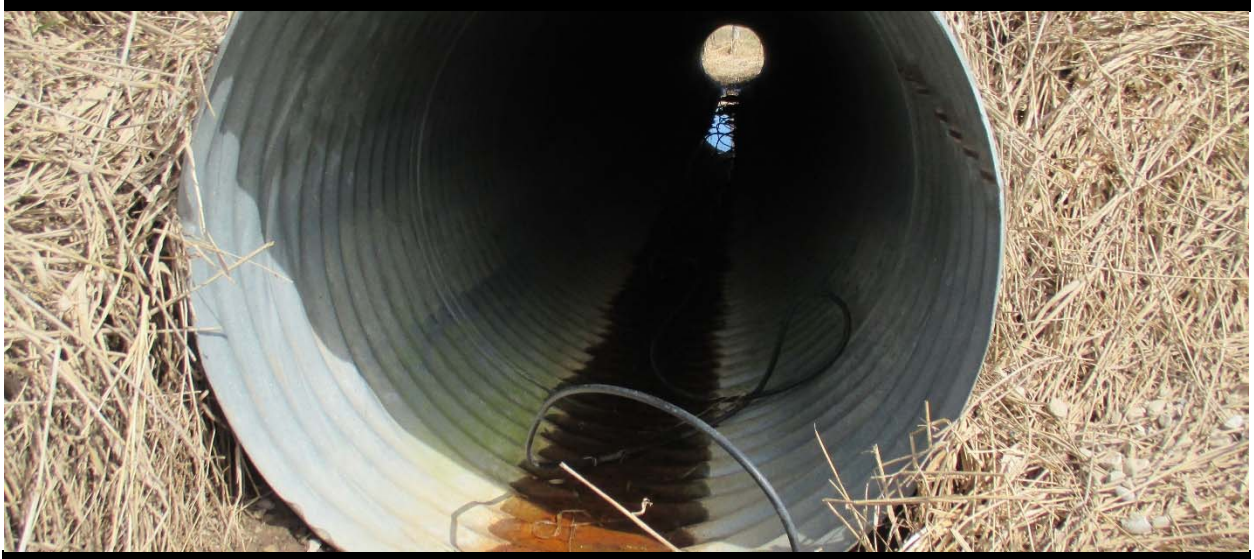
*Figure 9 Corrugated metal barrels are checked for surface damage, corrosion, abrasion, shape, joints and seams, alignment, and infiltration and exfiltration*

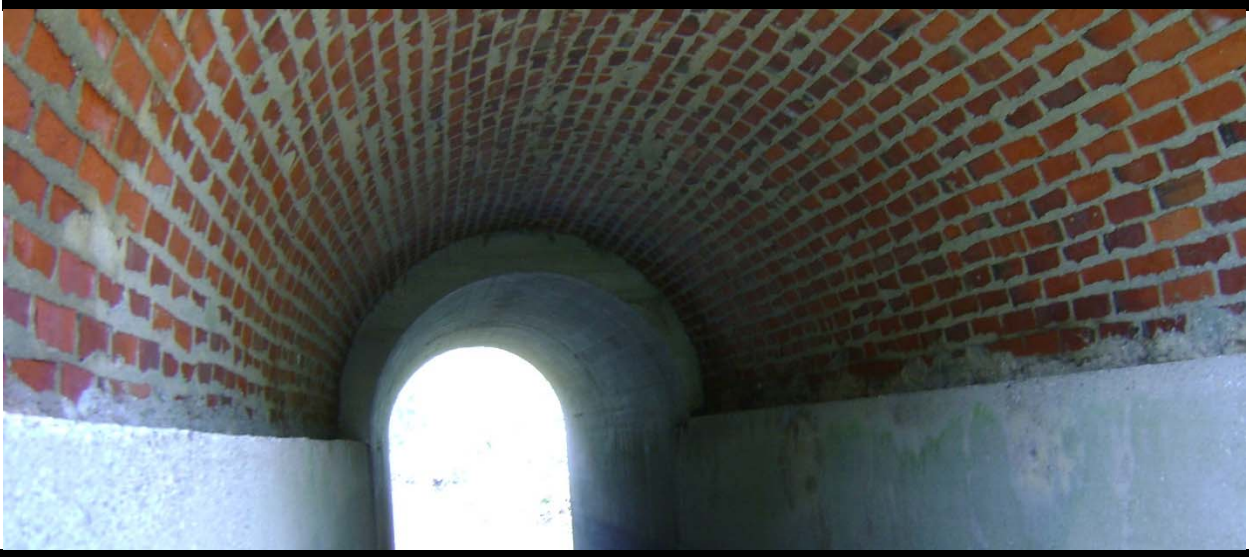
*Figure 10 Masonry barrels are checked for movement of masonry units, mortar, and efflorescence (photo: St. Clair County Road Commission)*

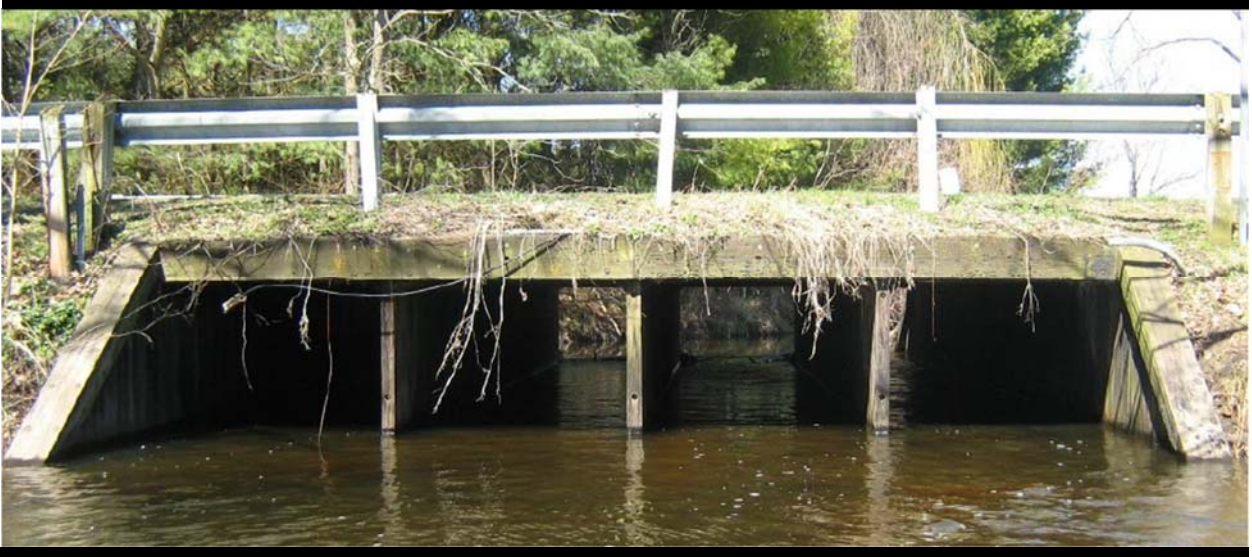
Figure 11 Timber barrels should be checked for connections and missing members, decay, checks and shakes, structural cracks, delamination, abrasion and impact, and distortion (photo: Fleis & Vandenbrink Engineering)
